Evaluation of a Class III Biological Safety Cabinet for Enclosure of an Ultracentrifuge

An evaluation of a special safety cabinet housing a high-speed centrifuge was made. The cabinet enclosed both the top access port and the drive and pumping machinery of the centrifuge. A titanium rotor was loaded with tubes containing a bacterial culture, weakened, and driven until rotor rupture occurred. There were several bent and broken components in the centrifuge, and bacteria leaked from the vacuum chamber. Although the forces were sufficient to displace the cabinet, none of the test bacteria were found outside the cabinet.

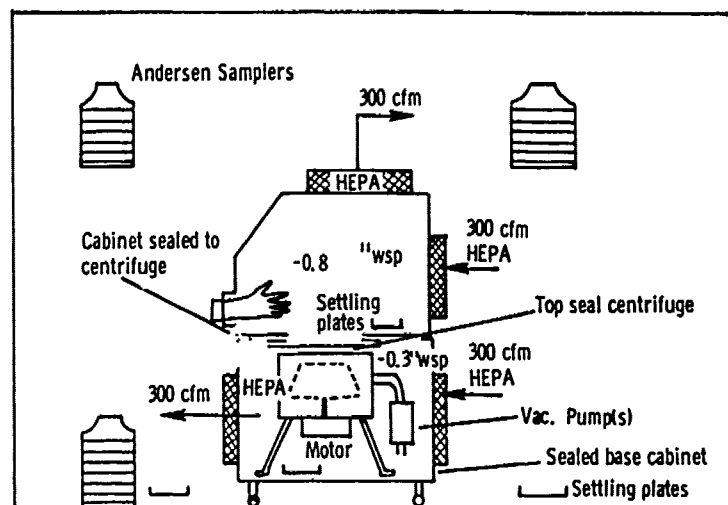
FIG. 1. Setup for test of Beckman L5 centrifuge rotor breakup in Baker class III cabinet. The test cell was ca. 8 ft by 10 ft by 10 ft (ca. 2.44 m by 3.04 m by 3.04 m).

tainment cabinet (Baker Co., Sanford, Me.). The top and bottom portions of the cabinet are separated by the centrifuge top, and are ventilated separately, through HEPA type filters, as shown in Fig. 1. The cabinet was connected to auxiliary exhaust blowers which exhausted 300 ft³/min of air through HEPA filters from the top and bottom sections of the cabinet which are isolated one from the other. Negative pressure of 0.8 inches of water (ca. 200 Pa) was maintained in the upper section and 0.3 inches of water (ca. 75 Pa) in the lower section housing the centrifuge mechanism.

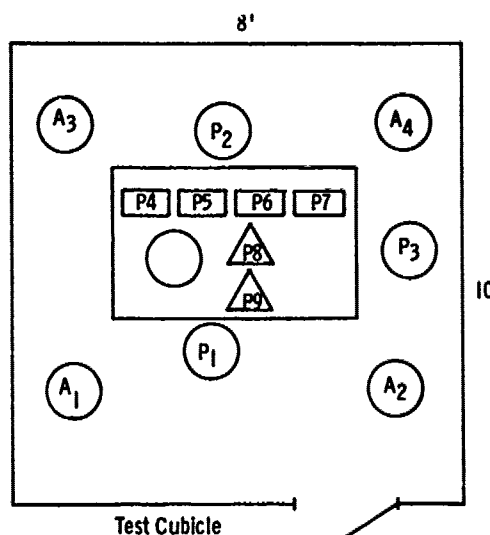
FIG. 2. Location of aerosol sampling stations in centrifuge test cell and in safety cabinet. Abbreviations and symbols: A, Anderson samplers; P, settling plates; ○, outside cabinet; □, inside upper cabinet on work surface; ▴, inside base cabinet, at bottom.

The samplers were numbered by sampling station and placed in the locations shown in Fig. 2.

Settling plates P-8 and P-9, in the bottom of the cabinet, were sealed into the cabinet and left open for up to 8 h, as were settling plates P-1, P-2, P-3, and P-4. Plates P-5, P-6, and P-7 were uncovered only after rupture of the rotor had occurred. Anderson sampler vacuum pumps were switched on only after the rupture of the rotor had occurred, and the Anderson samplers were run for two successive 20-min periods after the rupture. The test was constrained by the availability of only a single rotor to test to rupture. The settling plates were covered each time it was necessary to enter the test cubicle and the cabinet to remove the rotor and redrill it, and every effort was

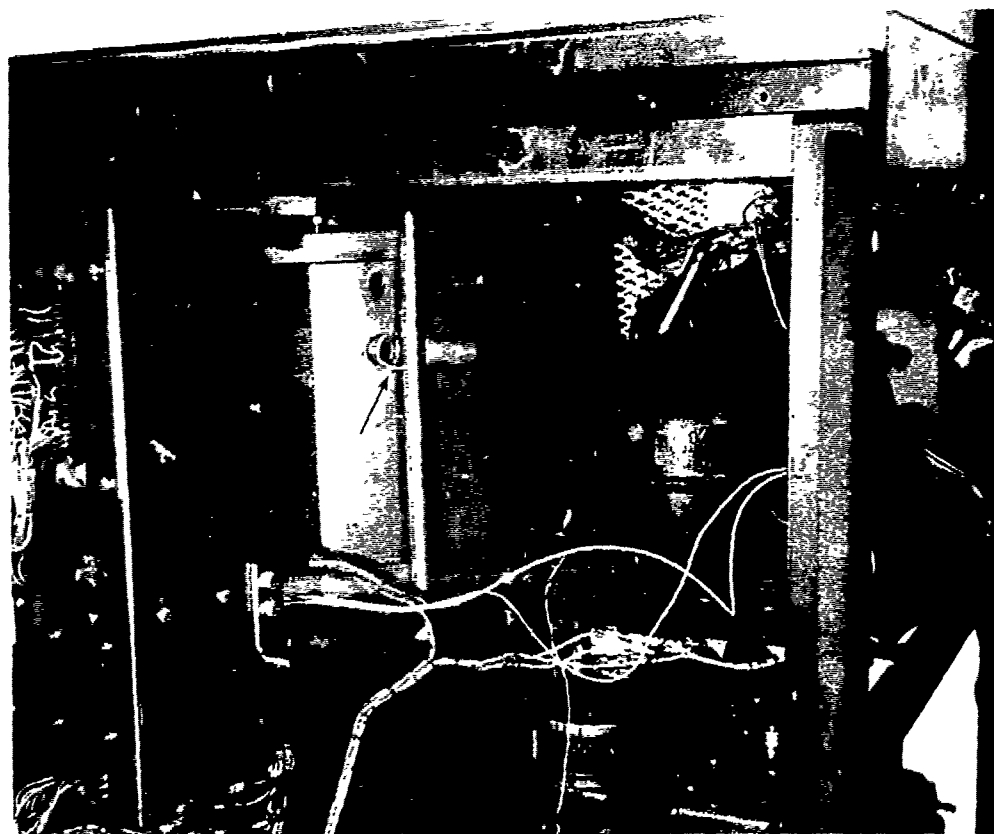
FIG. 3. View of vacuum pump connection and rotor enclosure in base of centrifuge.

the rotor ruptured at 53,000 rpm. There was an immediate and violent dislocation of the centrifuge within the cabinet, some distortion of the rotor chamber and the sliding cover, and a rupture of the line leading from the rotor chamber to the vacuum pump (Fig. 3). The Baker cabinet moved about 3 inches (ca. 7.62 cm) (Fig. 4A). The centrifuge remained within the cabinet and did no damage to the cabinet or to its biological integrity (Fig. 4B). The sliding top closure plate for the centrifuge vacuum chamber was bent sufficiently so that it did not open normally, and it required dismantling the rails for inspection of the ruptured rotor.

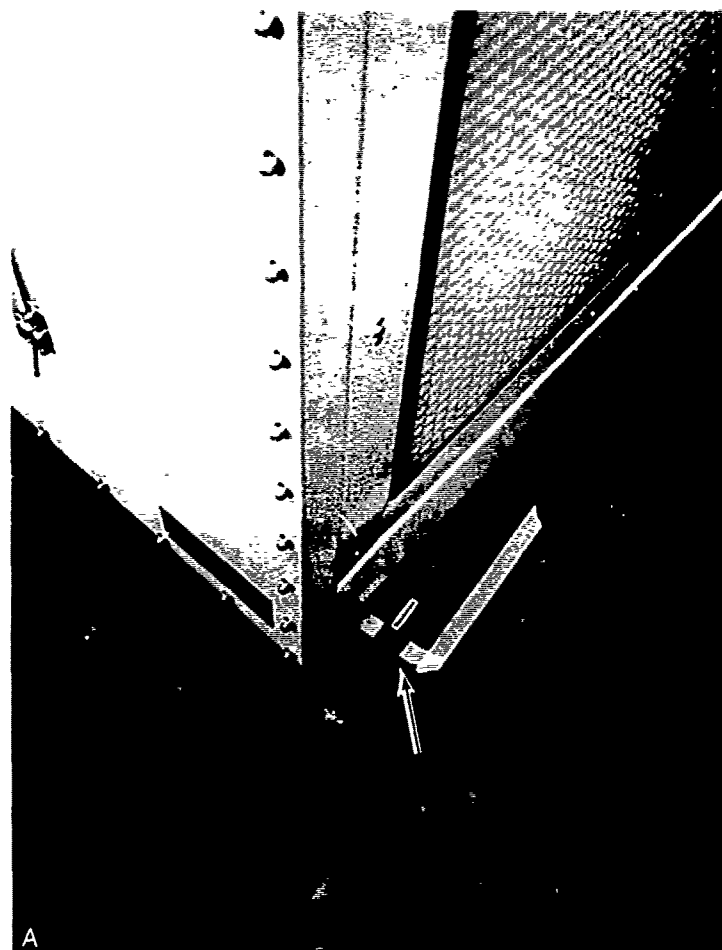
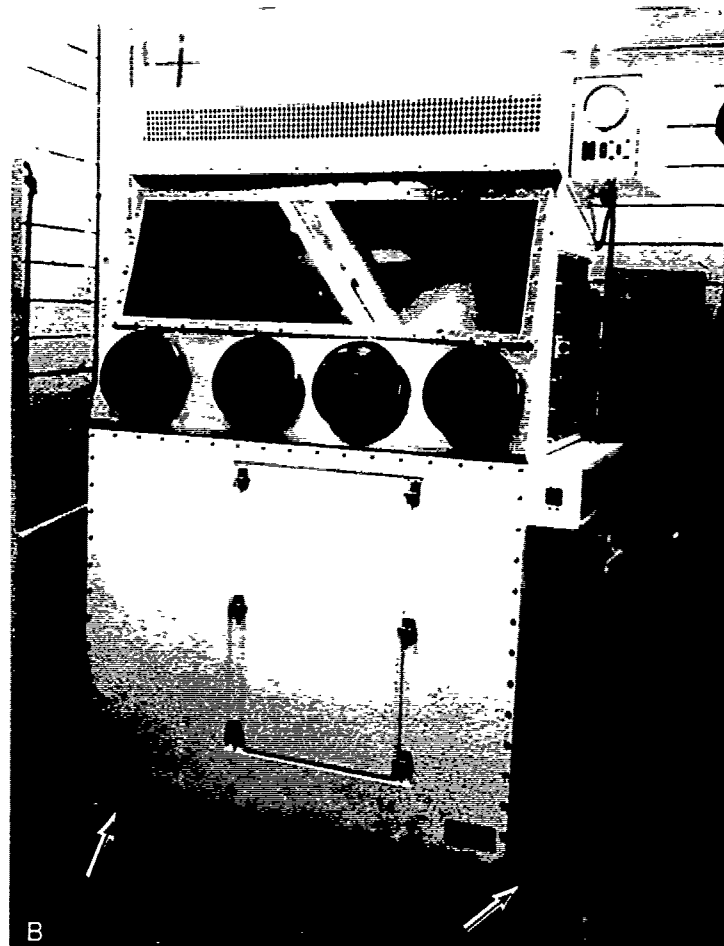
FIG. 4. B

FIG. 4. Views of special centrifuge enclosure showing movement after rotor rupture. (A) View of rear lower corner; (B) view looking at front.

rotation of the entire safety cabinet and the distortions of the rotor enclosure. This lends considerable emphasis to the requirement for total enclosure of the centrifuge if the agents under test are highly hazardous to the operator or the environment. Catastrophic failure of the rotor is extremely unlikely, provided manufacturer's recommendations for care and inspection of the rotor are followed. However, the combination of high-risk agent, high titer, and probability of incidence can act as a combination of power law factors, and the resultant dosage or "risk" estimated may be unacceptable. Work with hazardous agents like Marburg virus, Lassa fever virus, or the agents of Kuru or Creutzfeldt-Jakob disease at high titers are examples.
